DOE/ID-10965
Revision 0
April 2002

***Construction Complete Report for the Idaho
National Engineering and Environmental
Laboratory, Central Facilities Area, Operable
Unit 4-13, Transformer Yard (CFA-10)***

Published April 2002

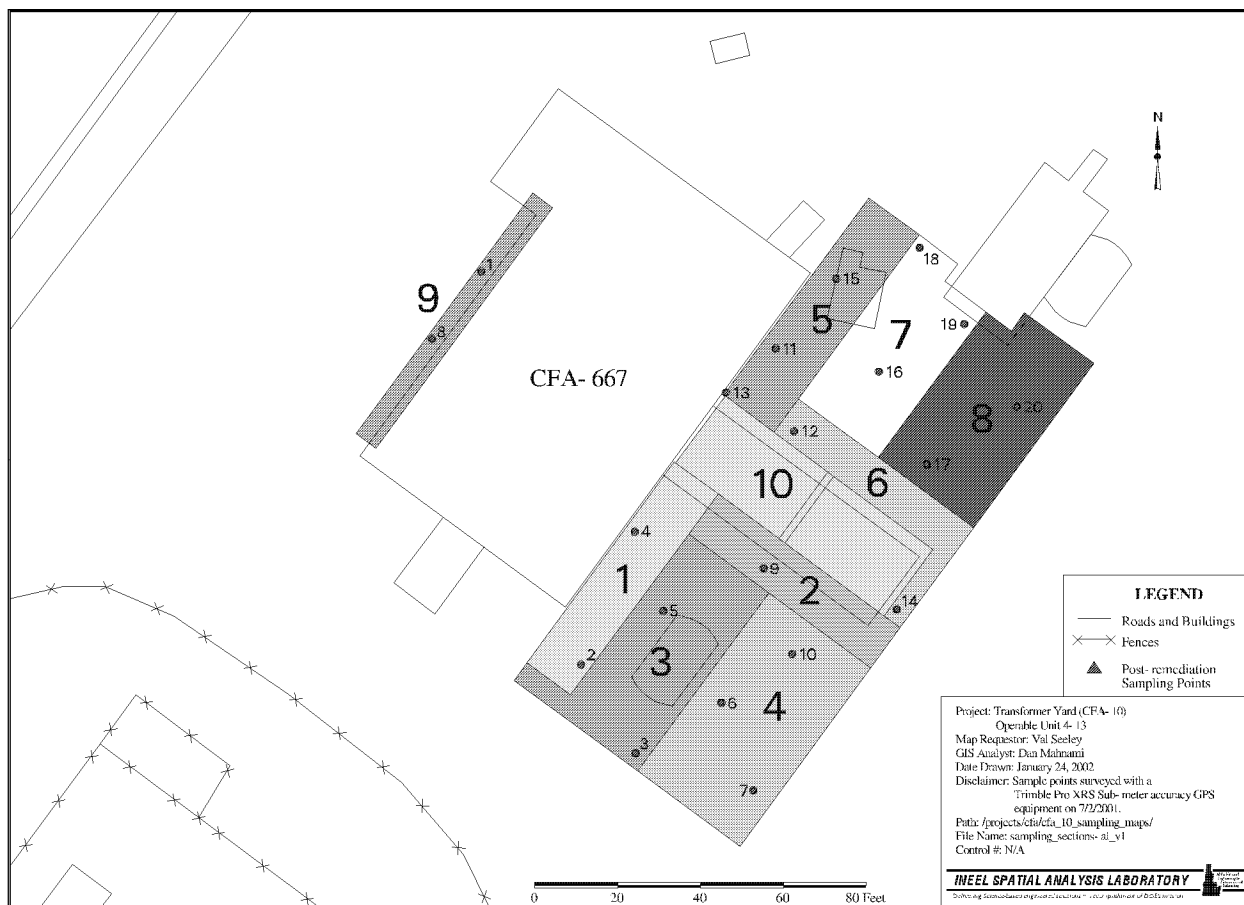
Figure 2. Sample locations for preremediation sampling.

Preremediation sampling to determine the waste disposition of the contaminated soils was performed in April 2001 (see Figure 2 for locations). The results indicated that all areas had total lead >400 mg/kg in the top 6 inches of soil. The highest lead levels occurred in Sector 5 at 9,260 mg/kg; Sector 1 at 3,140 mg/kg; and Sector 4 at 1,960 mg/kg. Sector 5 also had levels of 1,540-mg/kg total lead at 12 inches. The only area that had TCLP lead >5 mg/L, based on the previous RI/FS sampling, was in an 8 × 10-ft area near the southeast corner of the concrete pad in Sector 2. The complete results of the sampling are shown in Appendix C. The results from the preremediation sampling event confirmed that the concrete pad was not lead contaminated above the FRG of 400 mg/kg, and the concrete pad would not need to be removed.
